## Lessons learned from the field analysis of PV installations in the Saharawi refugee camps after 10 years of operation

This work presents the results of a field study conducted at the Saharawi refugee camps, inspecting the photovoltaic systems installed in the health institutions after 10 years of use. The main objective of the work has been to identify the technical and social issues related to the adequate operation of the photovoltaic systems at the health institutions within the camps so the electricity access can be guaranteed. A comparison with the situation in other camps or rural areas has been conducted in order to analyse the potential problems and most suitable solutions.

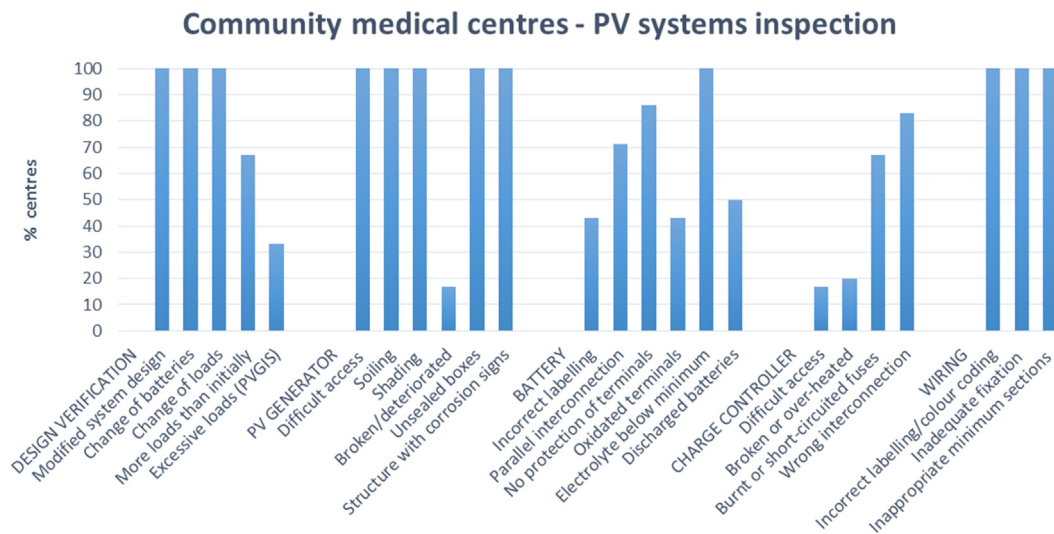
Fig. 3. Main issues regarding poor operation and maintenance of PV systems in community medical centres in the refugee camps of Tindouf, including aspects related to design verification, PV generator, batteries, charge controller, loads, wiring and inverters.

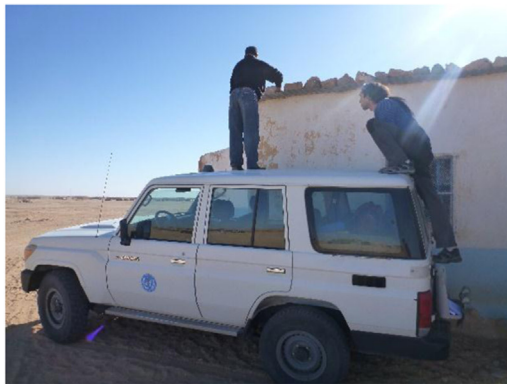
(a)

But there are other issues that have been found that are critical for the good operation and maintenance of the PV systems, such as the absence of easy access for PV module cleaning and connection boxes inspection (100% cases). In some cases, the easiest access to the PV installation had to be done by parking the car next to the rooftop and then jumping directly onto the rooftop (Fig. 4a). Another issue is the shading of PV modules by their own support structure and/or other

**Fig. 4.** Examples of issues related to the poor maintenance of the PV generator in community medical centres: a) absence of easy access to the PV generator for cleaning or inspection in Boukra (El Aiun), where the access had to be conducted by parking the car near the PV generator rooftop and then jumping directly; b) shading of the PV module in its edges by its own structure in Hagunia (El Aiun) and corrosion of the structure plus serious soiling on the surface of the PV; c) shading in the PV module produced by an external component, in this case a fence over the modules for protecting them from children using the modules as a slide in a park (Zug, Awserd); and d) shading produced by a tree in Gleibat el Fula (Dakhla).

*To solve this situation, it would be necessary to organise a strong training program on PV systems, including both general concepts (especially sizing and interconnection) and operation and maintenance. This should be also done when a new installation or update is planned by any agency, at the same time of the field work.* This would not only increase the current lifetime of the systems but also improve the living conditions of the Saharawi refugee population that continues relying on PV systems for the electricity supply in the health centres.

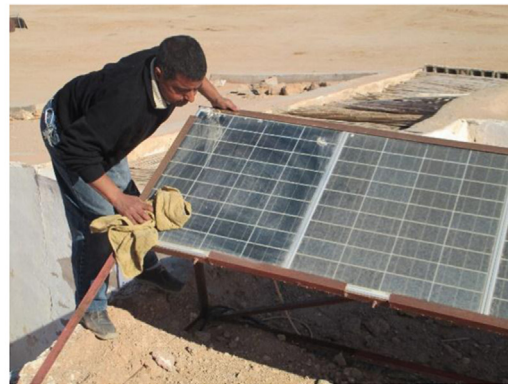
(b)

external elements (100% of the systems). In Fig. 4b an example of shading of the PV module by its own structure is shown, where it can be also observed the corrosion of the structure (100% cases) and the soiling on the PV module surface (100% cases). Fig. 4b also shows the serious soiling on the surface of PV modules, mainly from dust from the desert sand, which will have a high impact on the total power production, decreasing it dramatically. Another examples of shading on the PV modules are shown in Fig. 4c, where the shading is produced by a fence installed by the director of the community medical centre to protect the modules from children using them as a slide to play (Zug, Awserd); and in Fig. 4d, with a shade over the modules produced by the only tree found in the vicinity Gleibat el Fula (Dakhla). Finally, the last issue found is related to the connection boxes that were unsealed (100%), often with sand inside.

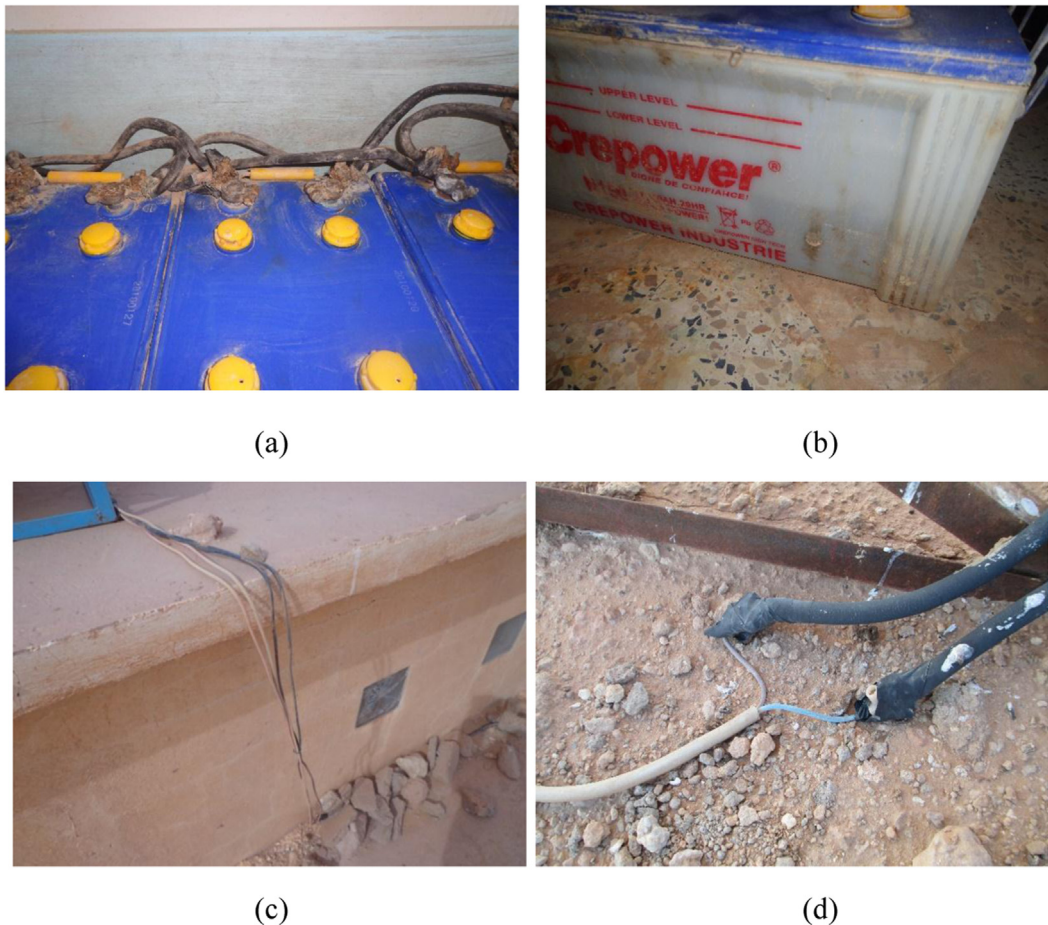
**Fig. 5.** Examples of issues related to the poor maintenance of the BOS in the community medical centres: a) oxidated terminals of batteries in Boukra (El Aiun); b) batteries electrolyte levels below the minimum in Hagunia (El Aiun); c) incorrect fixation of the wiring from the support structure to the walls, without protection in Zug (Awserd); and d) lack of use of wiring of appropriate sections in Boukra (El Aiun).

batteries (100%); and the fully discharge batteries (50%). Fig. 5a and b show several examples of these issues.

The interconnection and wiring presents several problems in all PV installations, from lack of correct labelling and colour coding (100% of cases), to inappropriate fixation to support structures and walls (100%) and lack of use of minimum sections of cable for the interconnections (100%). Fig. 5c and d show various examples found during the inspections.

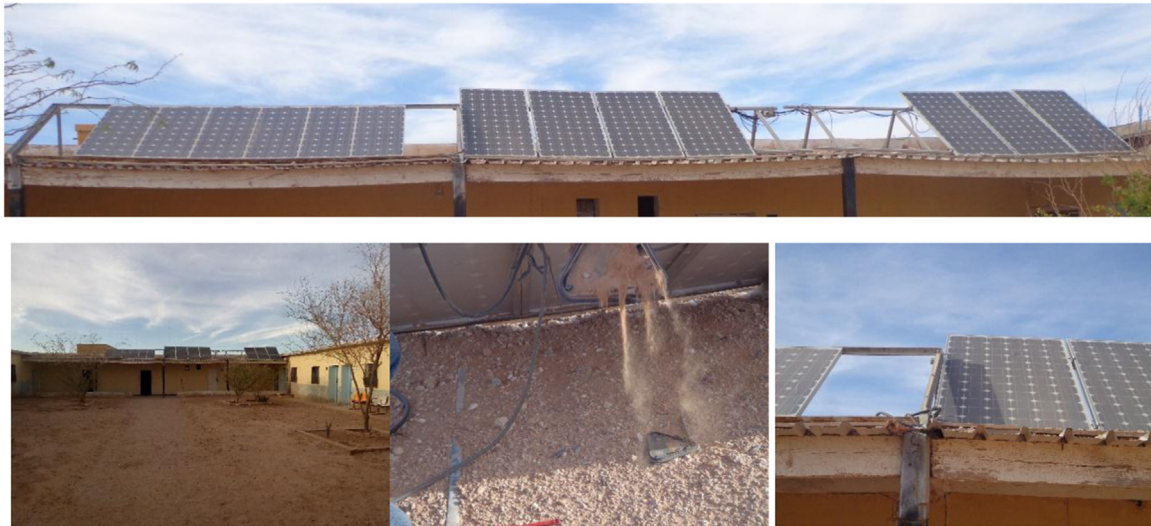
### a) El Aiun

Fig. 6. Regional hospitals and School of Nursing PV installations showing similar problems regarding operation and maintenance: a) El Aiun, overall view of the installation and detail of some issues, such as sand within the connection boxes and shading by misalignment of the PV structures; b) Awserd, problems with the PV generator showing burnt cells in the modules and poor wiring; c) Smara, burnt cells and broken glasses in the PV modules, poor wiring; d) Dakhla, overall view with a fixed antenna in the middle that provides shading over the PV modules, poor wiring and not appropriate location for the batteries; and e) School of Nursing, showing different types of PV modules with burnt cells, poor wiring.

and parallel in the same array, leading to performance losses and malfunctioning of the PV generator (causing hot spots).

(hospitals and school) were in poor conditions, including burnt cells and/or broken parts (glass). All the installations showed burnt cells within the modules. This is due to the wrong interconnection of modules of different characteristics (mismatch), which lead to hot spots that finally damage the modules and reduce their electrical performance, along with their average lifetime, down to 7 years when the normal values are 20 years.

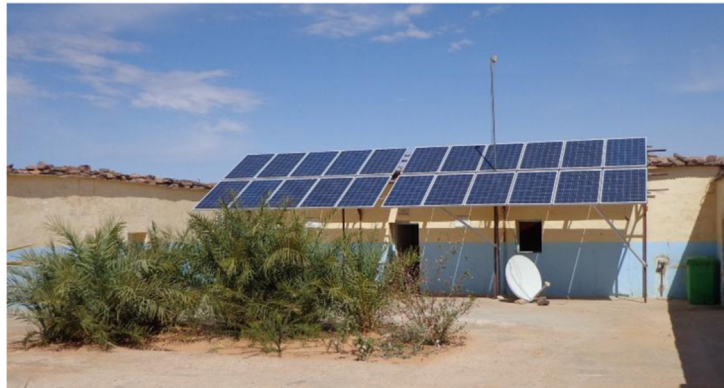
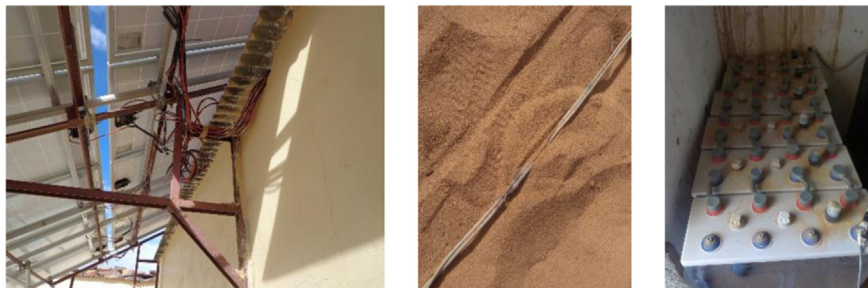
**d) Dakhla**

Regarding the batteries, their condition has been usually much better than in the case of community medical centres. They are usually in an appropriate location (except for Dakhla hospital), correctly labelled, adequately interconnected in series, and not fully discharged.
