Study of mode II fracture on fibre-reinforced gypsum notched specimens

Fernando Suárez^{a,*}, Javier F. Aceituno^a, Jesús Donaire-Ávila^a

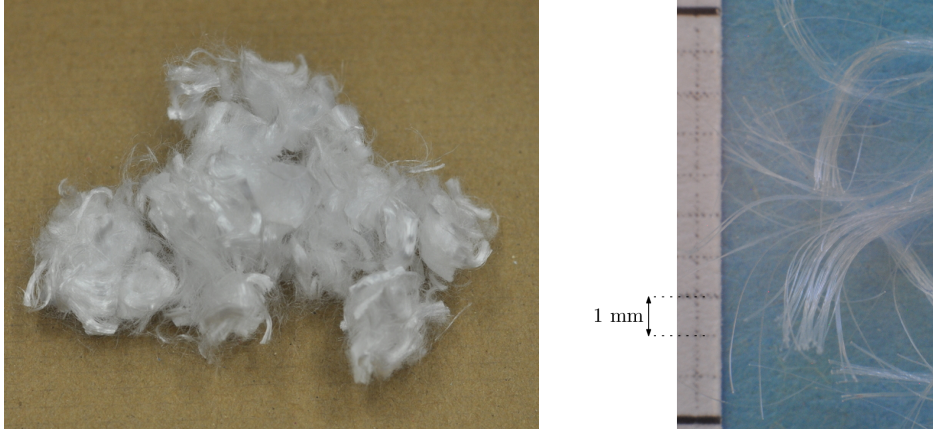
Figure 2: Polypropylene fibres used as reinforcement in the FRG specimens.

117 The fibres used here are polypropylene microfibres, named Sikafiber M-12, that are usually employed in
 118 concrete and mortars for reducing their cracking and increasing their durability. They are 12 mm long and
 119 their diameter is 31 μm ; the aspect of these fibres can be observed in Fig. 2.
